THE  
ECCLESIASTICAL  
ARCHITECTURE  
OF SCOTLAND

FROM THE EARLIEST CHRISTIAN TIMES TO THE  
SEVENTEENTH CENTURY

BY  
DAVID MACGIBBON AND THOMAS ROSS  
AUTHORS OF "THE CASTELLATED AND DOMESTIC ARCHITECTURE OF SCOTLAND"

VOLUME ONE

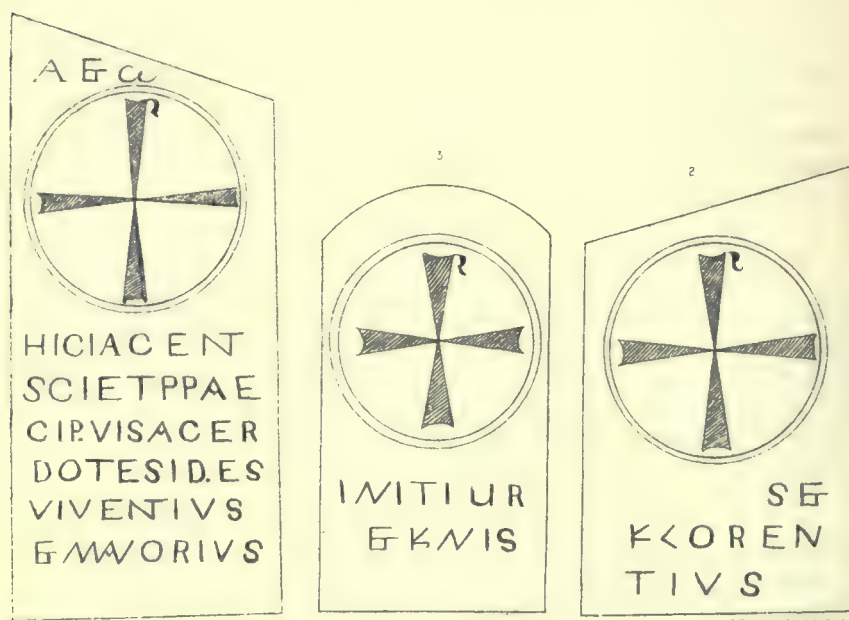
FIG. 1.—Early Crosses near Whithorn.

It tends to confirm the truth of the early mission of St. Ninian to the Southern Picts, that the monumental stones which still survive in that region are engraved with incised crosses of the oldest form, and are accompanied with inscriptions in debased Roman capital letters, containing the formula "hic jacet"—all marks which indicate a very early date.† Such are the crosses near Whithorn and those at Kirkmadrine, in a neighbouring parish, which all bear the simple cross with equal arms enclosed in a circle,‡ and contain the chi-rho symbol. (Fig. 1.)

The Scottish sculptured monuments, although bearing a general resemblance to the Irish, have several peculiarities. The earliest form of sculptured monuments in Scotland, as in the other Celtic divisions of Britain, consists of rude upright stones, engraved with an equal-armed cross enclosed in a circle, accompanied with an inscription in debased Roman capital letters, generally comprising the formula "hic jacet" and the chi-rho symbol. The carving is invariably incised in the stone. We have already met with examples of this class of monument, probably of the fifth century, in the South-West of Scotland, in connection with the *Candida Casa* of St. Ninian. (See Fig. 1.)

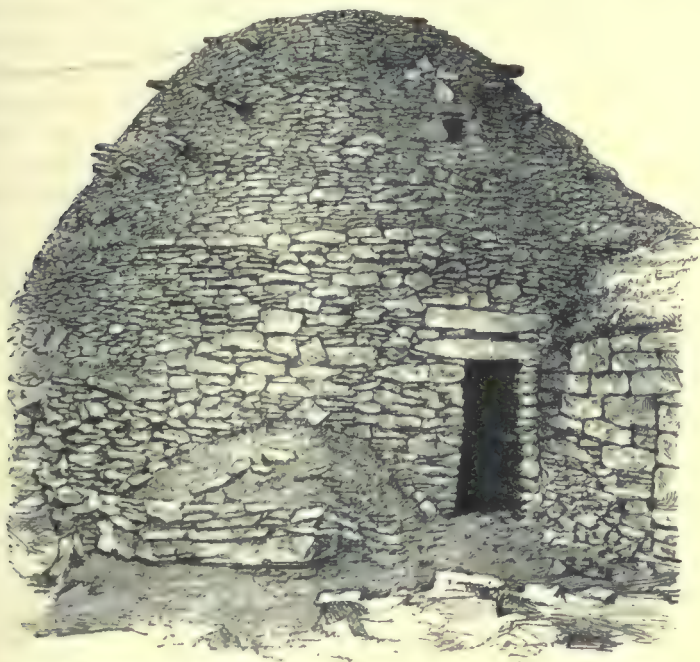
FIG. 2. -Beehive Cell on Skellig Mhichel. (From *Scotland in Early Christian Times*.)

Besides the great "cashel" or enclosing rampart, other stone buildings existed within the rath. These consisted of circular or oval huts, built with unhewn stones without mortar. They are generally about 6 to 10 feet in diameter, and the interior has sometimes square angles. The walls are 3 to 4 feet in thickness, and rise perpendicularly to about 6 feet in height, when they begin to converge towards the centre, the stones overlapping as they rise with a curve till they nearly meet, when the aperture is covered in on top with flagstones. The external appearance of these primitive abodes presents a domed form like that of a beehive,

from which circumstance they are called "beehive huts" (Fig. 2). There is invariably a small doorway about 4 feet high, with a straight lintel on top, and the jambs are always built, not perpendicularly, but with an inclination inwards as they rise. A small square opening in the roof, greatly splayed towards the interior, forms the window of the hut. Stone structures of this description were common in certain parts of Ireland in Pagan times.\* These were the native originals from which the Irish monks derived the style of stone building which was afterwards adopted by them in certain localities, with modifications as time progressed.

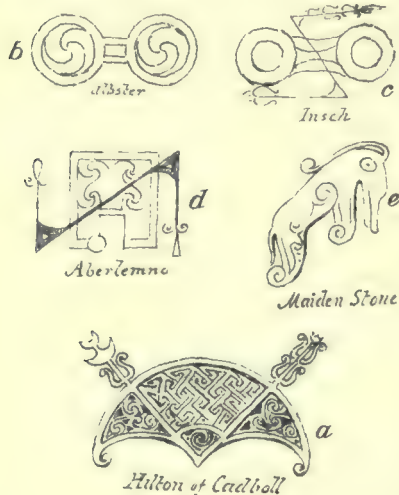
FIG. 3.—Symbols.  
(From Stuart's *Sculptured Monuments*.)

Certain peculiar forms of sculptured symbols, carved on undressed upright stones, seem to have originated amongst the Northern Picts. These symbols (Fig. 3) consist of the well-known symbol of (a) the "crescent and sceptre," (b) the "double disc" or "spectacles," (c) the above with sceptre, (d) the oblong with sceptre, (e) the "elephant," and other forms which are very common in the East of Scotland north of the Forth, but are unknown anywhere else. The meaning of these symbols has never been satisfactorily explained. In the earliest monuments the symbols and occasional figures are the only ornaments found on the stones. They are invariably incised and plain, contain-

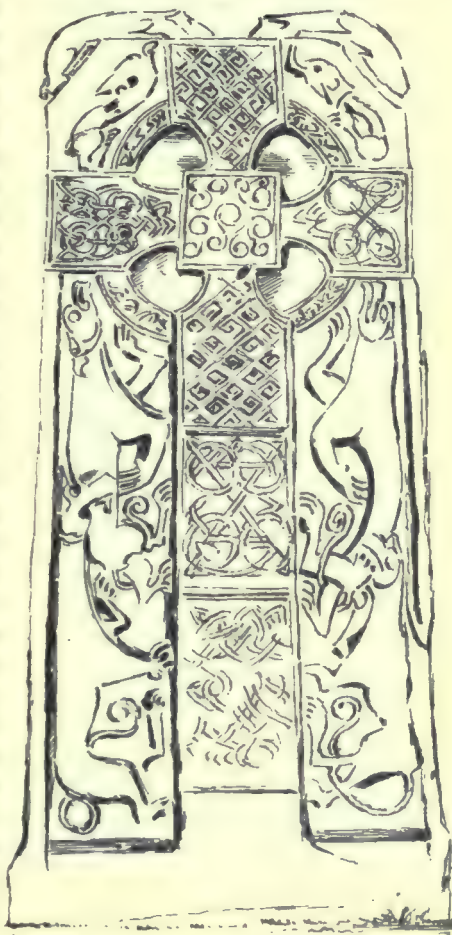
FIG. 4.—Cross at St. Madoc's, Perthshire.

in relief (Fig. 4). The oblong slabs are always upright, and ornamented on both sides, not recumbent like the Irish slabs. They generally bear on the obverse a cross of the Celtic form occupying the full size of the stone. This form of cross has the four angles at the junction of the arms with the upright shaft hollowed out with a circular or square recess, and the junction surrounded with a circular band. The oblong form of the slab is preserved entire, and the portions of the surface on each side of the cross are usually covered with sculptures representing symbols or interlaced patterns arranged in panels (Fig. 5). The cross itself and the other figures are carved with elaborate designs of interlaced work, or with frets or divergent spirals. The reverse of the slabs is also covered with sculpture representing symbols and conventional or symbolic figures (Fig. 6). The sculpture on these stones bears a close resemblance to the designs of the Celtic MSS., so close, indeed, that each sculptured monument might be a page of MS. carved in stone. This indicates, as pointed out by Dr. J. Anderson, that the designs were first wrought out and brought to perfection on the pages of the MSS., and reproduced at a subsequent period on the stone monuments. The earliest Celtic MSS. date from the end of the seventh century, while the decorated slabs are probably of the ninth to the twelfth centuries.\*

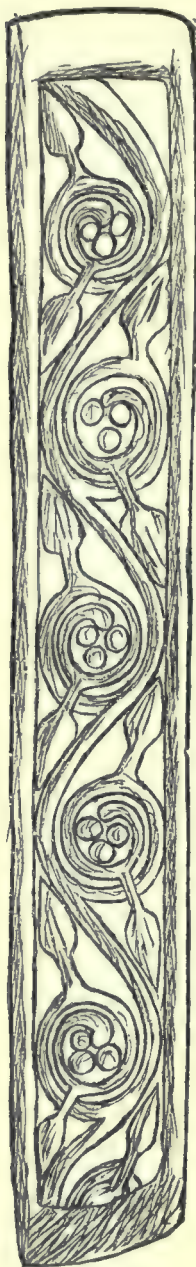
FIG. 7.—St. Vigeans,  
Forfarshire.  
(From *Scotland in  
Early Christian Times.*)

general progress of the country. It thus at length becomes merged in the general design of the twelfth century, as introduced from the South along with the other effects of the Roman influence. The interlaced work, spirlets, and fret work give place in course of time to scrolls and leaf ornaments (Fig. 7). The crosses, formerly enriched with divergent spirals, become carved with leaf or flower patterns, the peculiar Pictish symbols disappear, and the Celtic cross gives place to the more ordinary Norman form. Upright cross slabs are abandoned and recumbent slabs take their place.

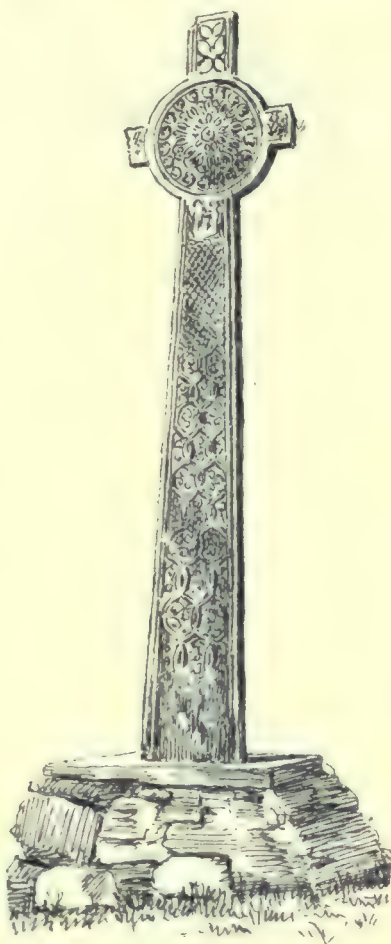
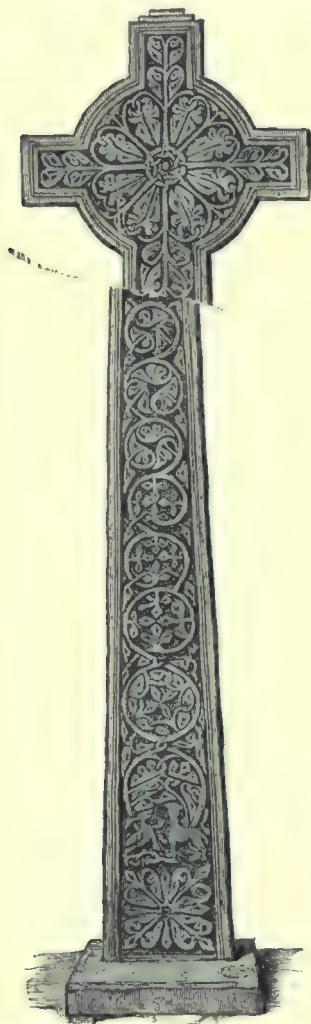
FIG. 9.—M'Lean's Cross, Iona.

The late Western crosses have, further, this peculiarity, that the circular band round the head of the cross is not cut free, so as to present an independent ring of stone, but forms a solid disc, from which the ends of the arms and top project. (Figs. 9 and 9A.) These crosses generally contain a representation of the Crucifixion, which is almost unknown in pure Celtic work. The carving also ceases by degrees to be distinctively Celtic, and consists generally of scroll work and foliage. (Fig. 10.) These features were adhered to in this region for centuries after the Celtic work of the East had entirely given place to the general Gothic art of the rest of Europe. (Fig. 11.) The monuments of the West thus retain a very special character, the foliage of the designs being unique and original, and in many cases of much beauty. This peculiar design continued as late as the sixteenth century, several good dated examples of that period being still preserved, mixed with debased Gothic

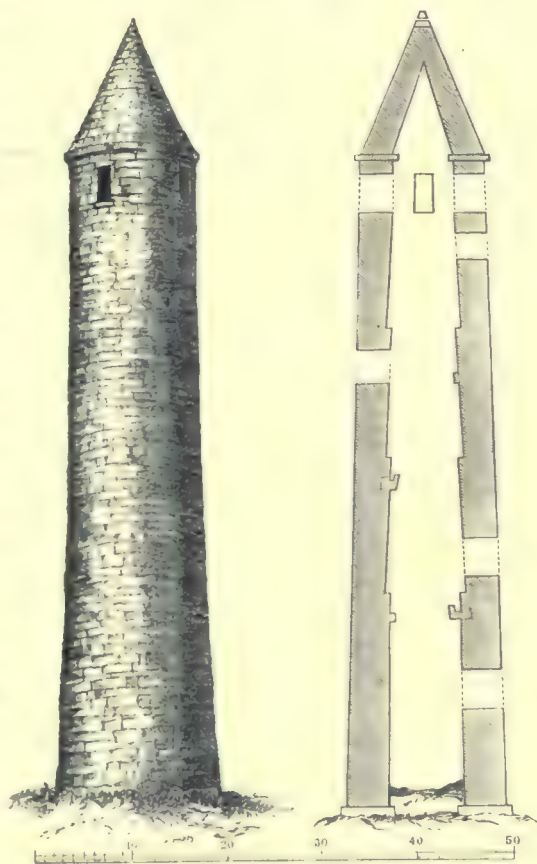
FIG. 12.—Irish Round Tower at Devenish. (From *Scotland in Early Christian Times*.)

The history of the round towers of Ireland is easily traced in their architecture, and has been fully explained and illustrated by Dr. Petrie in his well-known book on the subject, and in the late Lord Dunraven's beautiful work on the early structures of Ireland. These towers are always found associated with religious sites. The earliest examples are comparatively rude in structure, while the later ones gradually improve in style of masonry and finish, until the latest are built with ashlar work, and contain some Romanesque ornaments and details. In all, however, the leading principles of their construction are the same. (Fig. 12.) The tower is round on plan, and is finished on top with a conical roof. The door is narrow, and is placed, for security, at a considerable height above the ground, and the lower floor is sometimes built up solid, so as to resist conflagration. The windows are small, except those on the top story, which are generally set facing the cardinal points, and are larger, so as to allow the sound of the bell to be heard—one of the uses of the tower being to serve as a belfry. The Irish practice of inclining the jambs of the doors is maintained, and in the early examples the lintel is straight,

while in the later ones the door is finished with a semi-circular arch, and enriched with several orders of mouldings and ornaments bearing a markedly Norman character. This remark applies also to the four windows of the top story, which are plain in the early examples, and gradually become more ornamental and Norman like. The Irish towers are almost invariably built alone, and free from other structures; but some late examples are constructed in connection with churches, and enter from them by a door on the level of the floor of the church. The idea of using these towers as a place of security is thus departed from, and they are then simply of use as belfries.\* Finally, they become absorbed into the structure of the church, and are erected merely to serve as belfries on the gable.

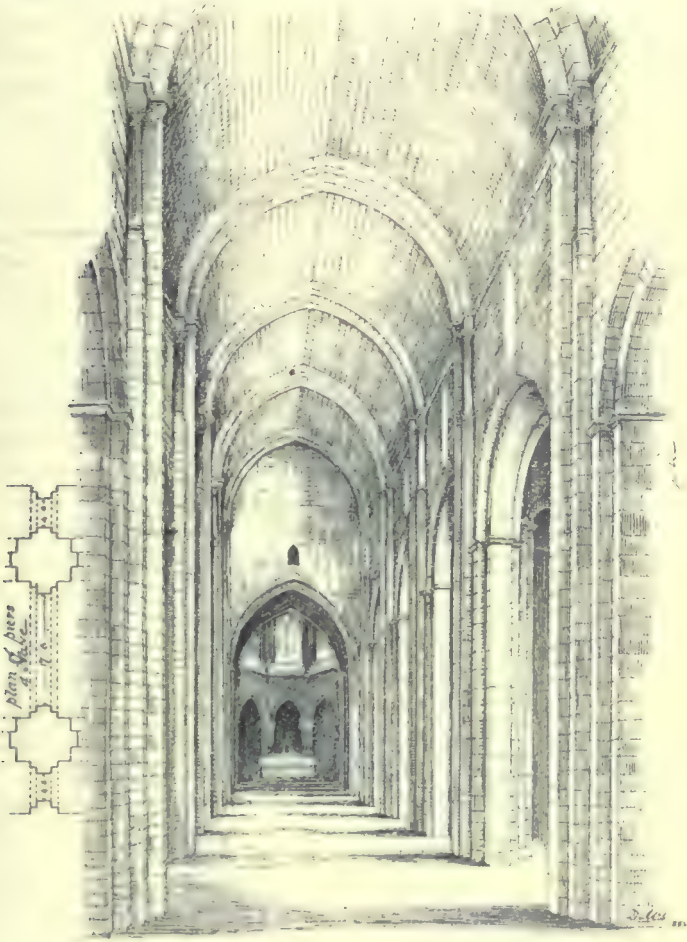
FIG. 15.—St. Trophime, Arles.

Owing to the occurrence of frequent fires in the wooden roofs of early churches, the builders aimed at carrying out the Roman practice of fireproof vaulting. This was at first done timidly and with many failures. The round barrel vault of the Romans was that generally employed; but in Provence the pointed barrel vault (Fig. 15) was adopted

from an early period, being a form which exerted on the side walls a less horizontal thrust than the semi-circular arch, and was the best shape for supporting a stone roof laid upon it. In order to strengthen this vault, a projecting ring or inner arch was constructed under the main vault, and extended across the nave between each pair of the main piers.

Carrying out the principle of subordination already introduced, each of these strengthening rings had a shaft with cap and base placed so as to receive it, thus indicating to the eye the principle on which it acted—viz., that of carrying the weight of the strengthening rib down to the foundation.

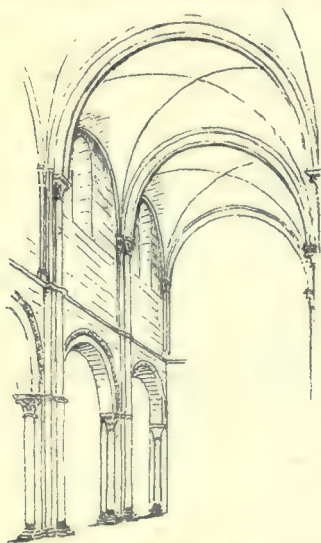
FIG. 16.—Groined Vault.

By the eleventh century the principle of subordination had been carried out into every part of the structure, and some refinement was beginning to be attempted; shafts were substituted for the plain orders of the piers, and a cap and base provided for each (see Fig. 14), and the sharp angles of the orders of the arch were softened by having large roll mouldings wrought upon them. The next step in the progress of development was the subdividing or groining of the vault, so as to admit of windows for the purpose of lighting the upper part of the building, which, with the barrel vault, was found to be very dark. (Fig. 16).

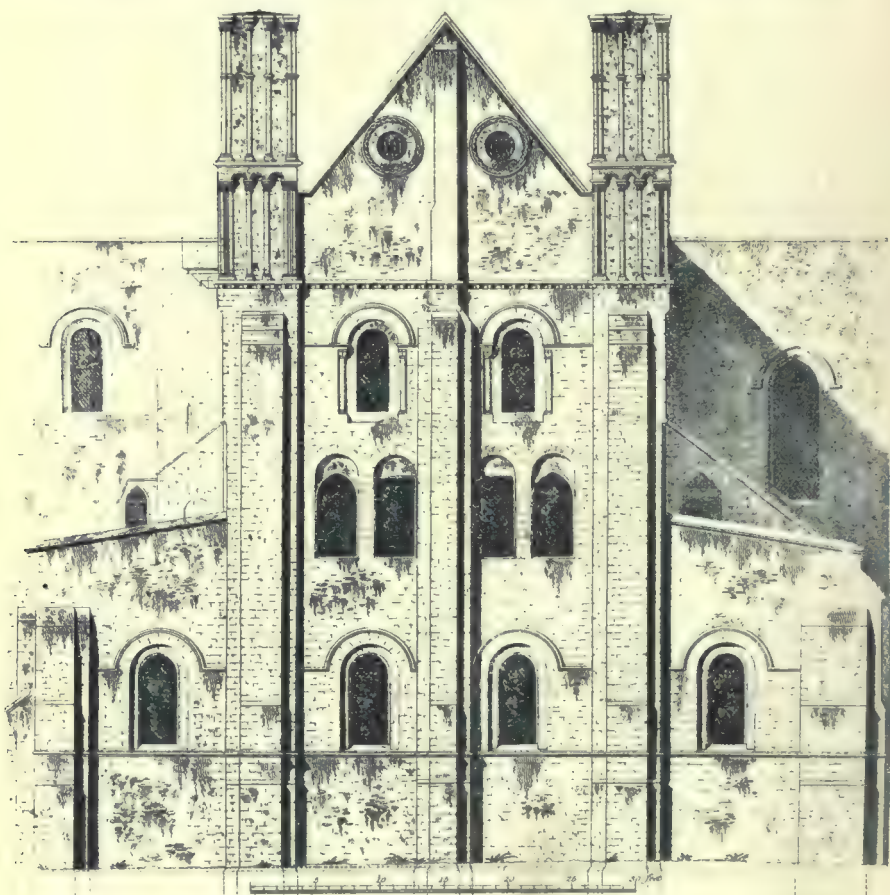
FIG. 17.—Church of St. Cross, Hampshire. Elevation of the East End.  
(From Britton's *Antiquities*.)

This style is easily recognised by its simple and massive forms and its semi-circular arches. The exterior (Fig. 17) is generally plain, with broad and slightly projecting buttresses attached to the building, and sometimes

crowned with pinnacles. The doorways are, however, generally treated in a more ornamental manner. They are often deeply recessed, and have the jambs decorated with a series of round shafts set in square nooks or recesses, and furnished with richly-carved caps and bases. The arch

mouldings, which are also numerous, are arranged in square steps or orders, and frequently ornamented with much carving of special kinds of enrichments. Of these the chevron, or zig-zag, is most abundantly used, together with the billet, the bird's head, &c. The windows are wide in proportion to their height, and are covered in with round arches.

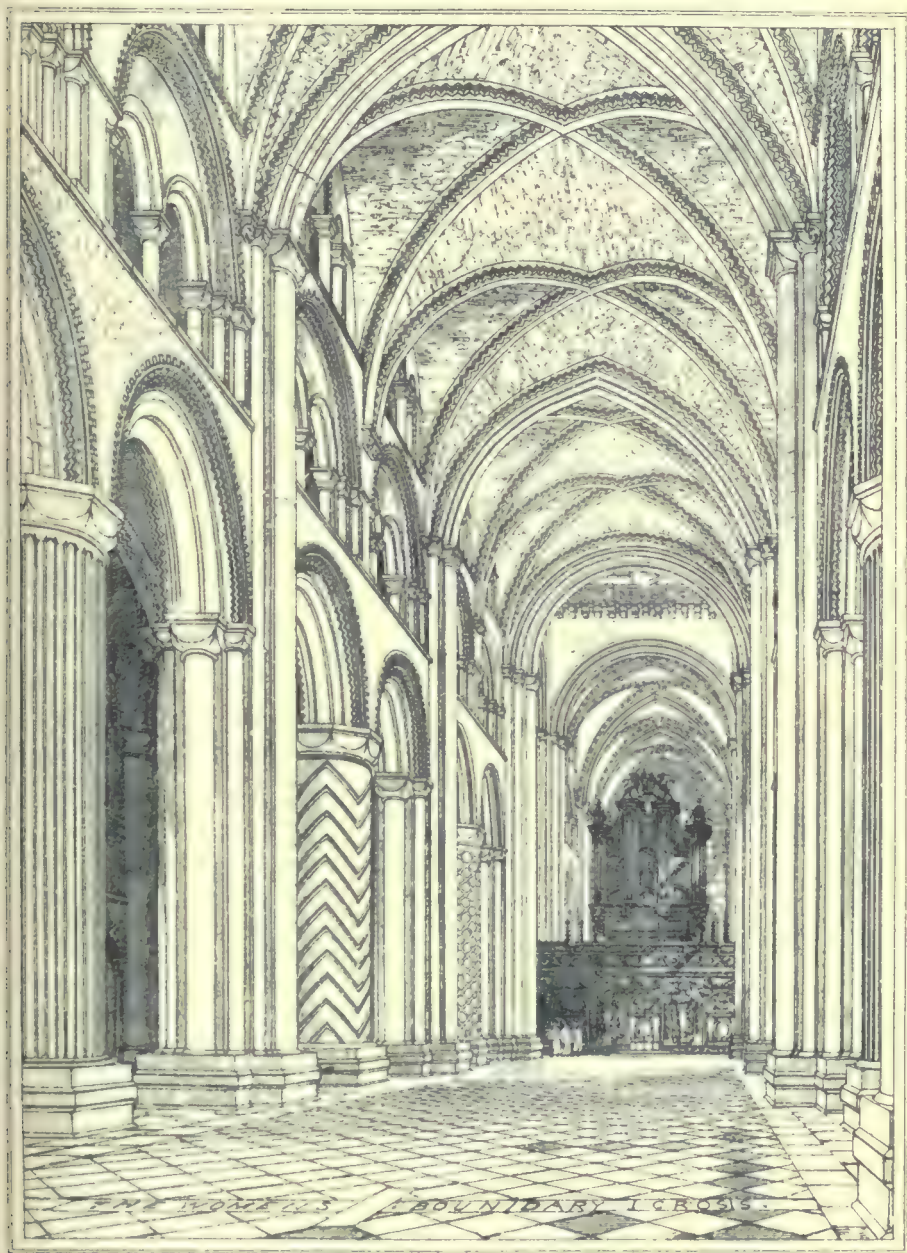
FIG. 18.—Durham Cathedral. The Nave.  
(From Billings' *Durham Cathedral*.)

In the interior (Fig. 18) the Norman piers consist of simple cylindrical columns of great size, frequently carved with large zig-zags or spiral lines carried round them, and finished with bold caps and bases. The most frequent caps are of the "cushion" form, which resembles one or more spherical figures having portions cut off perpendicularly. The caps are also sometimes carved with human or other figures. The abacus is always solid, and generally square in shape. In some examples, especially in France, the capitals of the piers are frequently carved in rude imitation of the Corinthian form and foliage.

The general design of the nave recalls that of Durham Cathedral, at the founding of which King Malcolm Canmore was present. The same circular piers, with zig-zag ornaments and massive cushion caps, and also clustered piers, occur in each (Fig. 209), and the small circular bases, resting on great square plinths, are common to both (see also p. 37, Fig. 18). The arches between the main piers (Fig. 210) consist of bold mouldings, with the label ornament running round the outer moulding. The triforium at Dunfermline is extremely simple (Fig. 211), consisting of a single opening with plain jambs and round arch, with a large roll and fillet in the centre of the thickness of the wall, supported on single attached shafts with cushion caps. The clerestory is also very simple. It contains one window in each bay, with plain recessed arch, supported on single shafts with cushion caps. The aisles (Fig. 212) are vaulted and groined. The transverse arches are flat, with a roll on each side, and the diagonal groins spring from the detached shafts of the responds (see Fig. 208). The windows of the aisles (see Fig. 209) are single round-headed lights, having plain sconsons with one recessed shaft on each side, and the arch enriched with chevron mouldings. Externally (Fig. 213) they are of similar design.

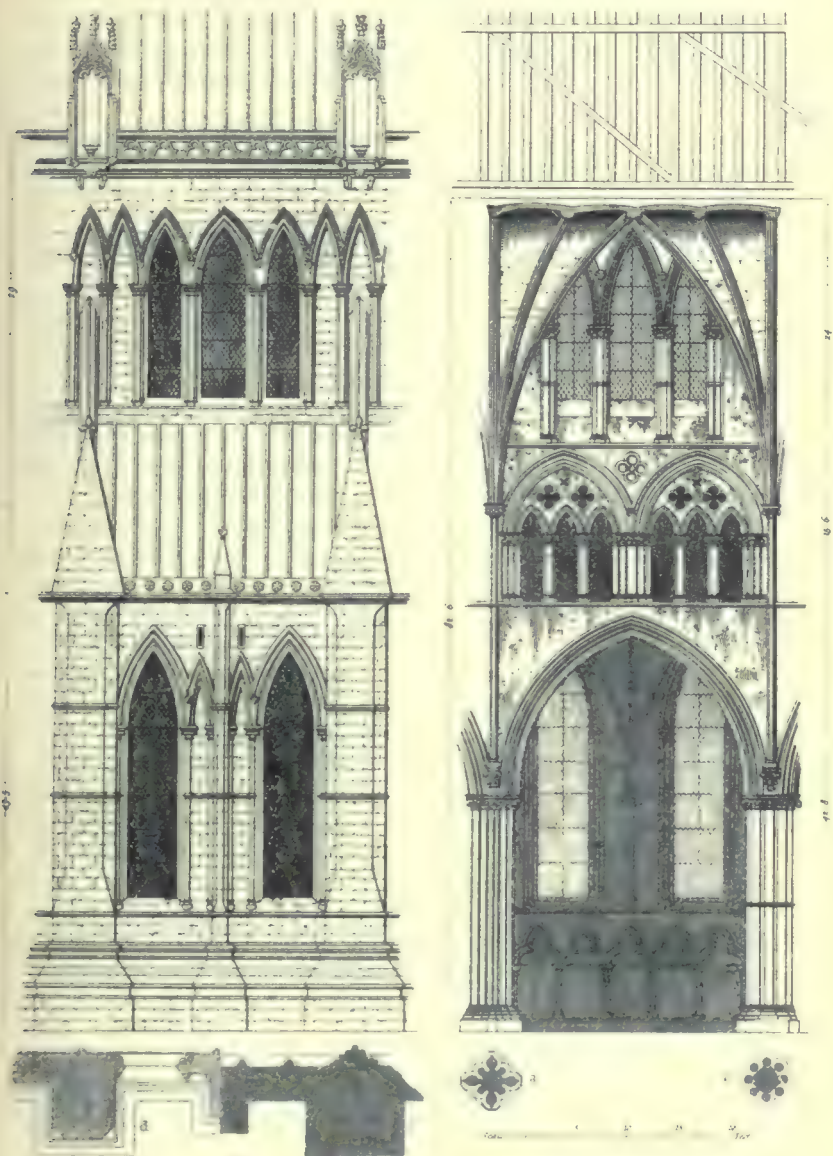
FIG. 22.—Lincoln Cathedral. Compartment of the Nave, Exterior and Interior  
(From Britton's *Chronological History of English Architecture*.)

The characteristics of the first or early pointed style in France and England are as distinct and apparent as those of the Norman. The general effect of the exterior (Fig. 22) is lighter than in the latter style, though still solid. The buttresses have greater projection and less breadth than the Norman ones, and are often lightened by having the outer angles chamfered. The water tables of the set-offs are also steeper, the pinnacles are thinner and loftier, and the buttresses are crowned with gablets and finials. In late

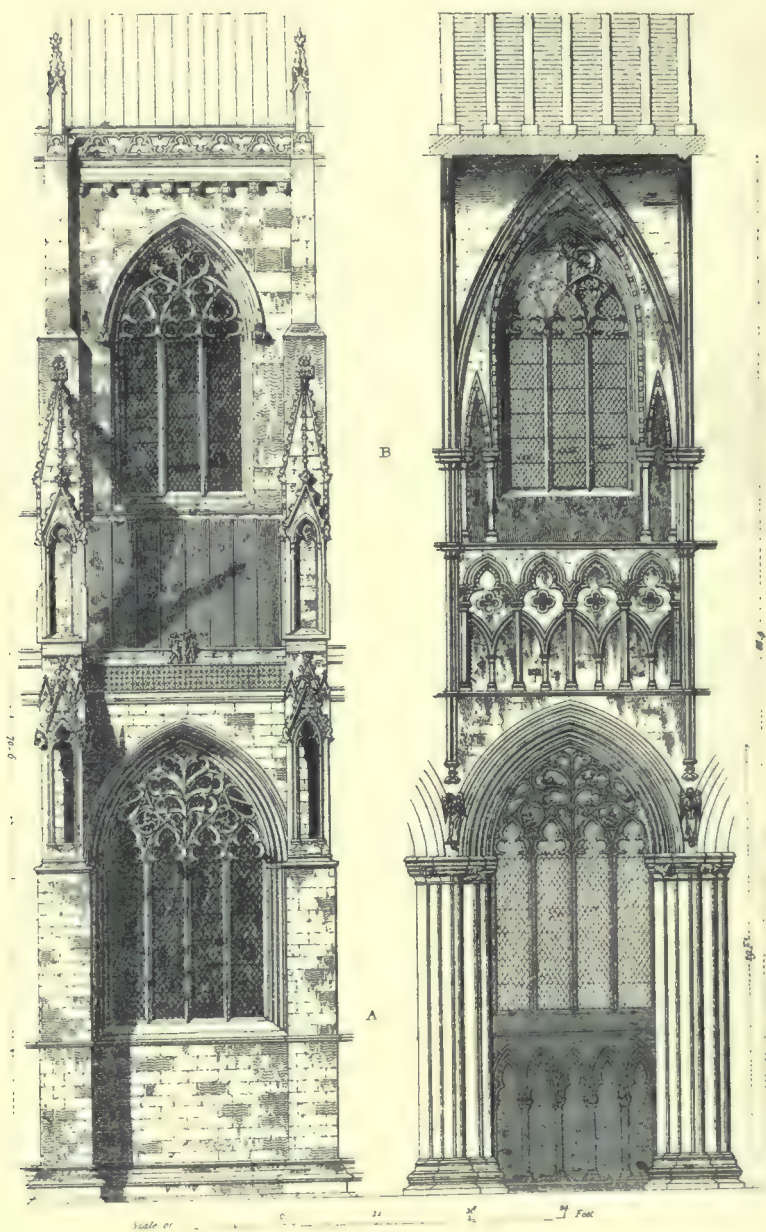
FIG. 23.—Beverley Minster, Yorkshire. Compartment of Nave, Exterior and Interior.  
(From Britton's *Antiquities*.)

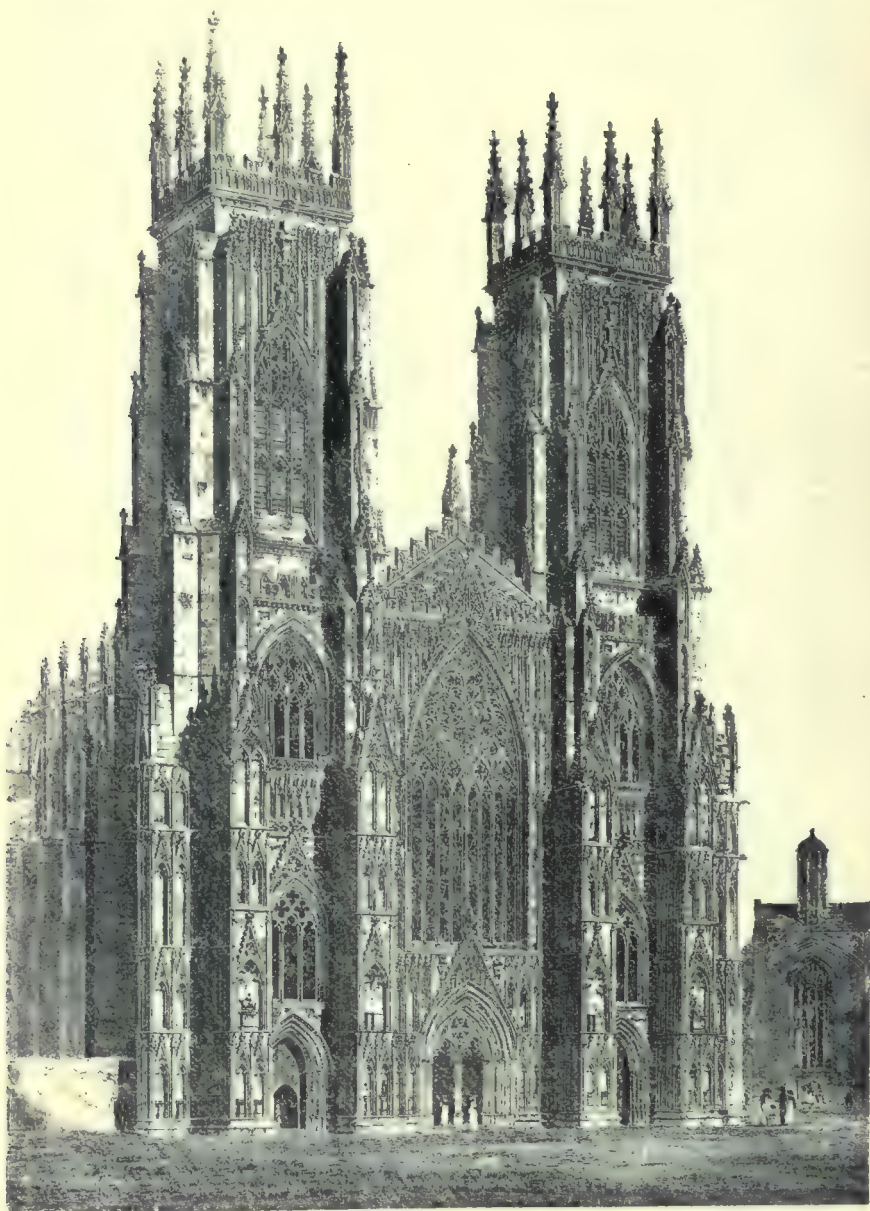
FIG. 24.—York Cathedral. West Front.  
(From Britton's *Cathedrals*.)

The doorways in England, although still much smaller than those of France, are, notwithstanding, often very fine, as, for instance, those of York Minster (Fig. 24). The shafts of the jambs, which in the previous period were detached and set in nooks, are now converted by degrees into a series of mouldings wrought upon the jamb stones, and arranged in one plane. The caps, at first distinct, gradually pass into a series of foliaceous scrolls running along the top of the whole jamb.

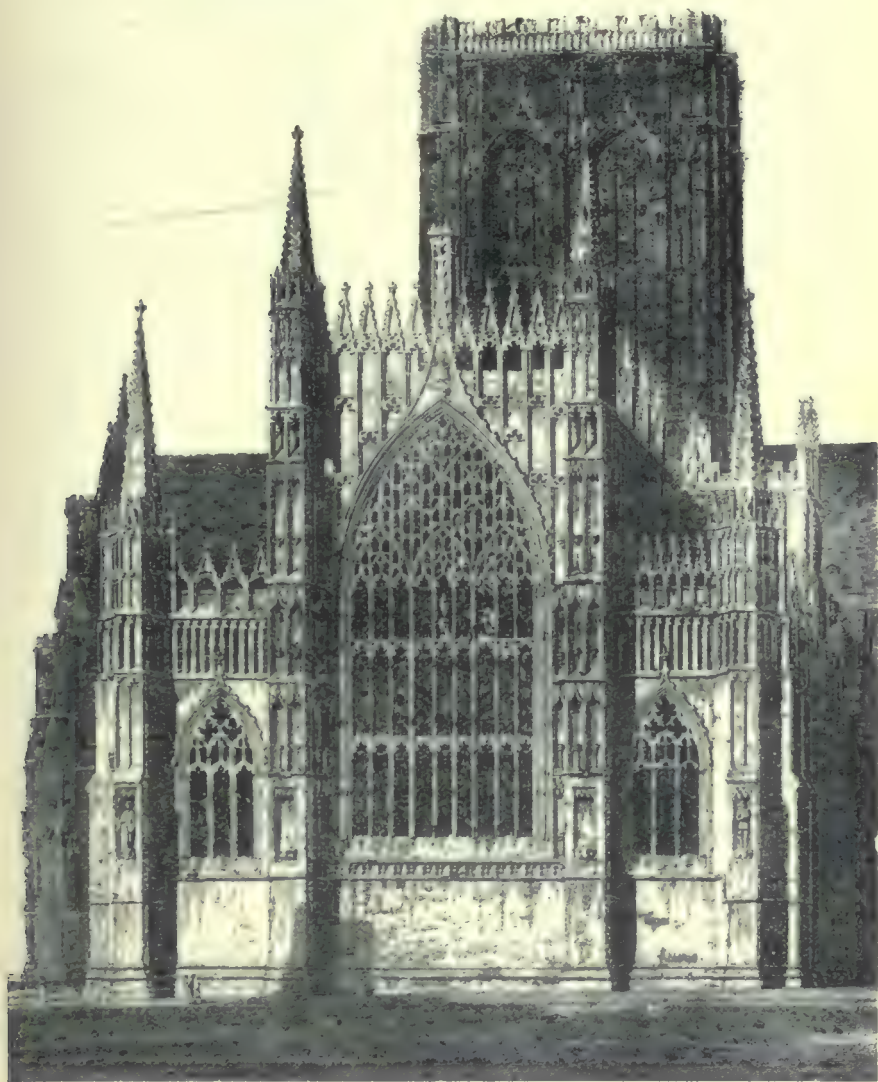
FIG. 25.—York Cathedral. View of the East End. (From Britton's *Cathedrals*.)

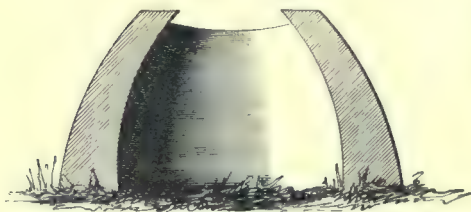
FIG. 27.

Mr. Muir then describes “another building, an underground cell of irregular oval shape (Fig. 27), measuring 5 feet 4 inches by 4 feet 5 inches, with a depth of rather more than 4 feet. The roof is formed simply by a few heavy slabs laid across the walls on a level with the ground outside, and the entrance is by a slanting aperture (Fig. 28), just where the roof and the walls unite. Two other buildings (Fig. 29), forming a part of this curious group, remain to be described. These are dome-shaped and joined together; the larger one internally 14 feet in diameter, the other about a foot less. The two buildings communicate with each other by means

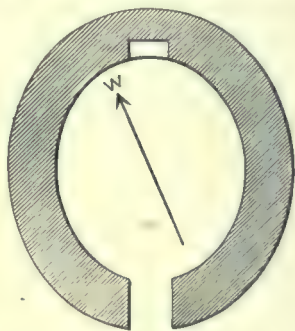
FIG. 28.

Eilean Naomh. Beehive Hut.

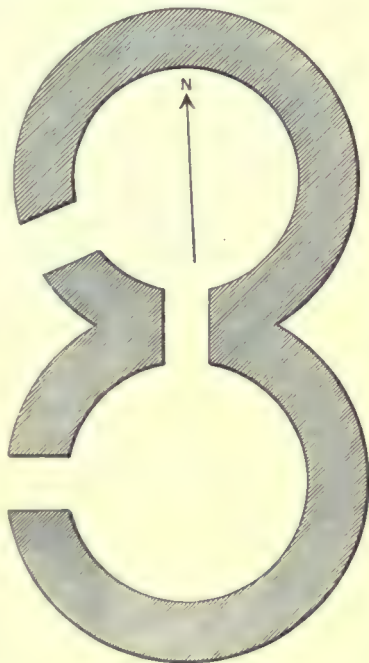
FIG. 29. —Eilean Naomh.  
Twin Beehive Huts.

of a square-shaped doorway through the point of contact, and the larger one with the outside by another doorway of the like kind facing the south-west; but with the exception of a square aperture at the ground, more like a gutter hole than a door, there is no external opening in the smaller building.”† The dome of the smaller structure is complete, but that of the larger is ruined. (Fig. 30.)

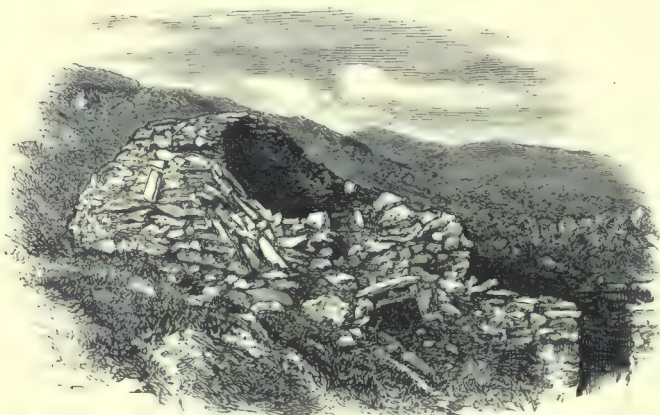
FIG. 30. —Beehive Huts on Eilean Naomh. (From *Scotland in Early Christian Times*.)

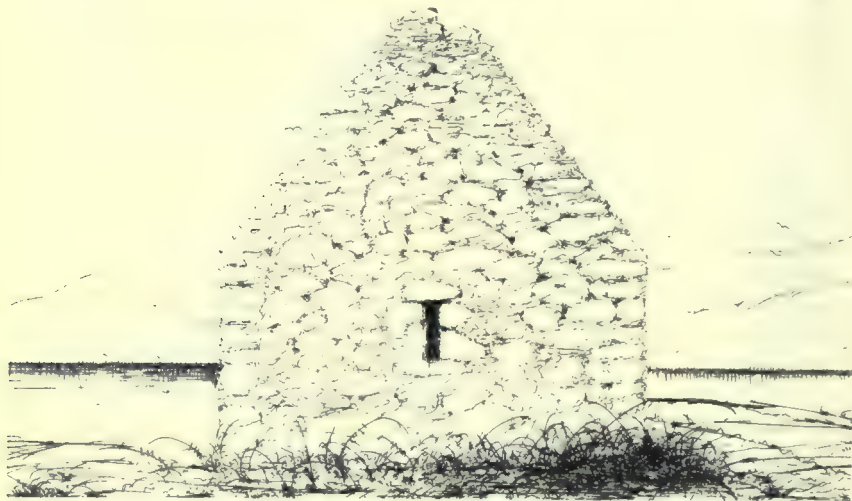
FIG. 31. —Skeabost, Skye. East Elevation.

ground containing a group of five or six chapels, the shell of two pretty entire, the others reduced nearly to the ground. Of the former, the one least perfect (Fig. 31) is a featureless building, externally 82 feet in length; the other—probably that mentioned in the *Originales Parochiales* as dedicated to St. Columba—is externally 21 feet in length, and has a flat-headed window (Fig. 32), 2 feet in height and 6 inches wide, in the east end, the west end blank. In the larger building there is a basin of a baptismal font, square, with rounded corners.”\*

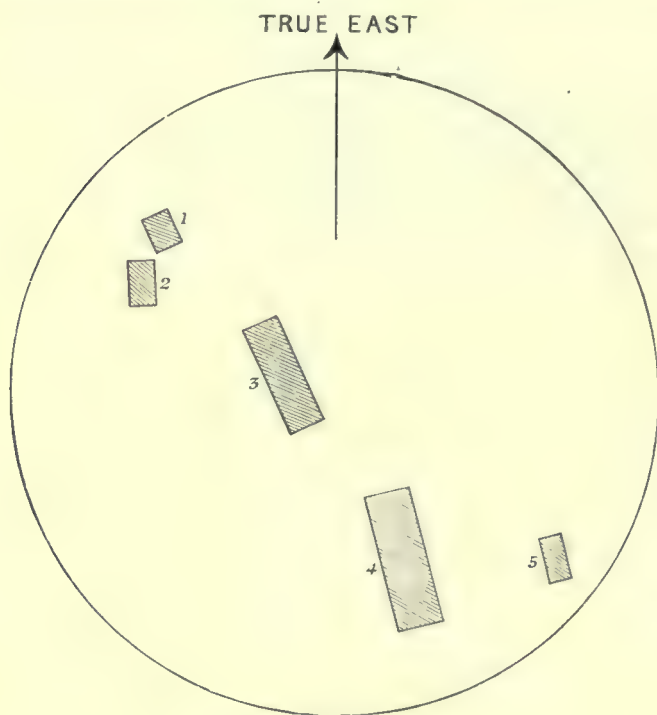
FIG. 33.—Hogmore, South Uist.

At Mr. Muir's first visit there were here remains of a group of five chapels (Fig. 33) all close together, but on his second visit he found one removed. "The missing one was a very characteristic building, the smallest of the group, with a very narrow rectangular window and a short *sloping* doorway in the east end. Externally it measured only  $17\frac{1}{2}$  feet in length.

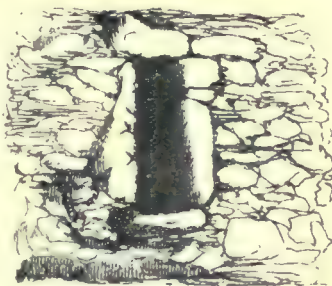
Of those still remaining, the largest has been about 60 feet in length. Scarcely anything of it is standing more than the east wall, a long cruciform couplet [widely splayed inside and looking like first pointed],\* in which shows that the building had been the finest and largest of the lot. The next largest is internally rather more than 54 feet in length. Of it, also, the only remains is the east wall [pierced with a narrow flat-headed window (Fig. 34), 2 feet long and 6 inches wide, extremely rude].\* The

FIG. 34.—Howmore. East Window.

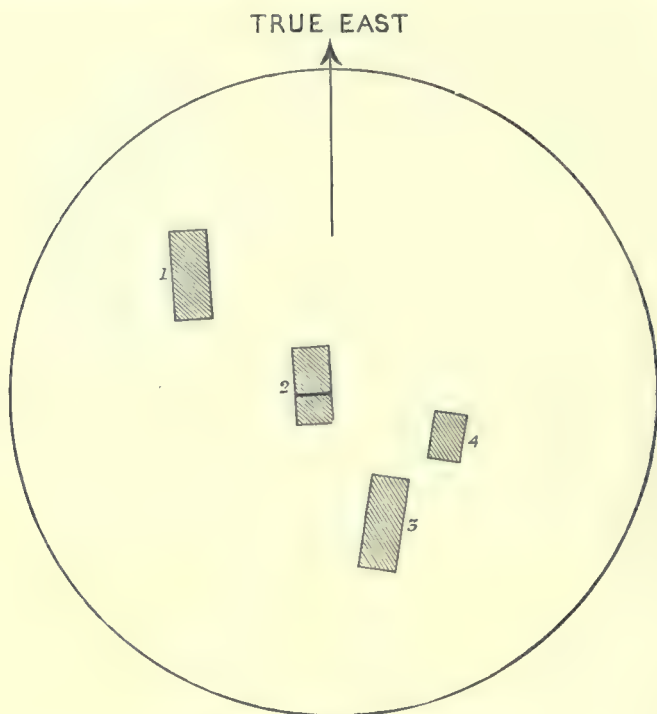
In a burying-ground, “three dilapidated chapels, resembling very much those at Howmore. The largest (Fig. 35) (supposed to be that of St. Barr), (1) is externally 42 feet in length; the end walls nearly away, the north and south walls nearly entire. The north side has a rude triangular-headed doorway (Fig. 36) enclosed in a semi-circular arch, and a triangular-headed window on its east. In the south wall there are three windows of the same form—two of them together near its east end, and one near the west end. Against the east end the altar remains almost entire. The next largest chapel (2) is externally 30 feet in length; it is divided by a dead wall into two unequal apartments, each having a flat-headed doorway on the south. The east end contains a flat-headed window 16 inches in length by 3½ inches wide, and there are windows of like kind in the side walls, the west one blank. Of the third and smallest chapel (4), externally 18 feet 3 inches in length, very little is left. At my first visit (July 1855) both ends were entire, the east one containing a small flat-topped window, the west one blank; now (July 1866) the only detail is a narrow window at the eastern extremity of the north wall, the head round, and formed of one stone.”§

FIG. 35.—Kilbar, Barra.

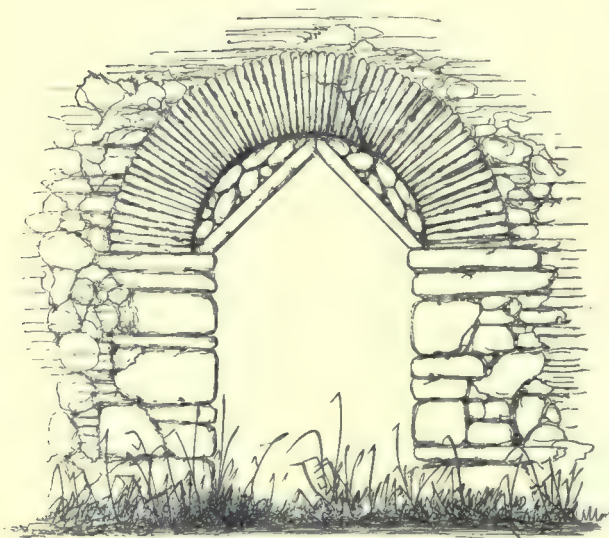
FIG. 36.—Kilbar, St. Mary.

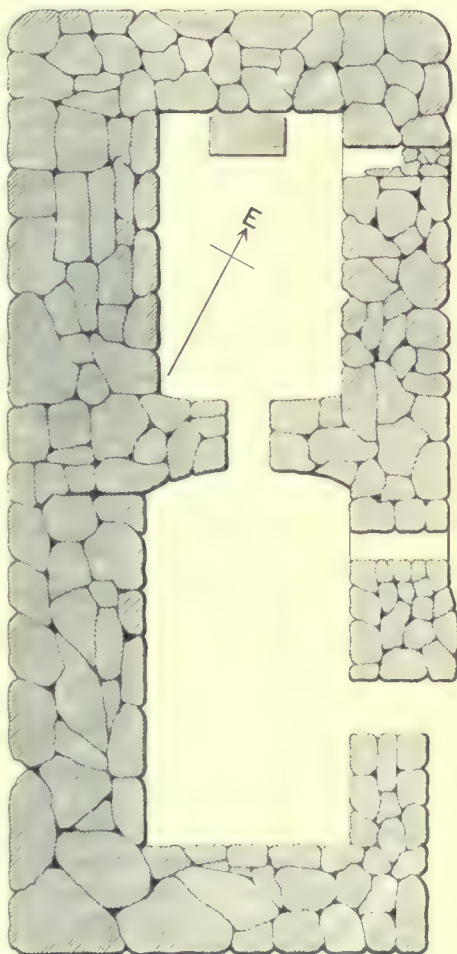
“Of this rude and diminutive building [the eastern chamber] not much can be said. On the outside it is in most part a rounded heap of loose stones, roofed over with turf. Within you find it a roughly-built cell (Fig. 37), 9 feet 3 inches in height, and at the floor 11 feet 6 inches long and 7 feet 6 inches wide. The end walls lean inwardly a little, the side ones so greatly that when they meet the flat slab-formed roof they are scarcely 2 feet apart. (Fig. 38.) Beyond the singularity of its shape, there is nothing remarkable in the building, its only minute features being a

FIG. 37.—Teampull Rona.

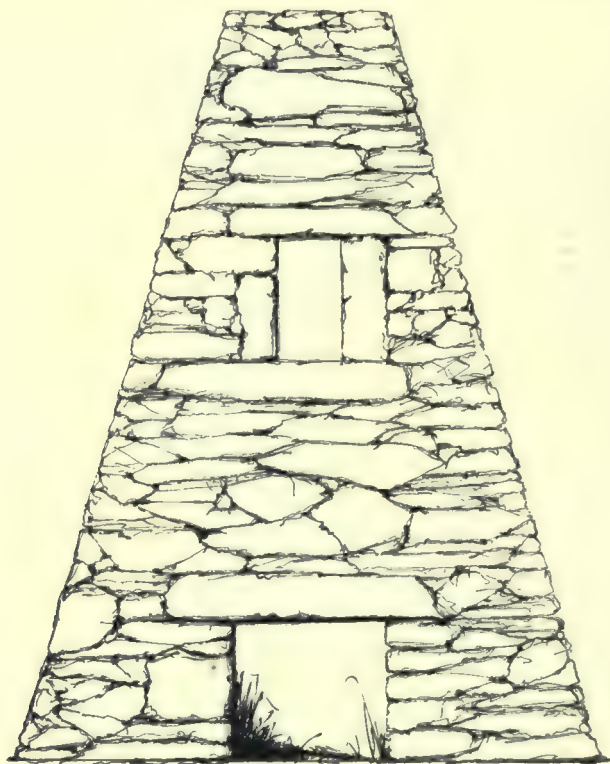
square doorway in the west end, so low that you have to creep through it on your elbows and knees ; a flat-headed window without splay on either side, 19 inches long and 8 inches wide, set over the doorway (see Fig. 38) ; another window of like form and length, but an inch or two wider, near the east end of the south wall ; and the altar stone, 3 feet in length, lying close to the east end.

FIG. 38.—Teampull Rona. Interior West End Elevation.

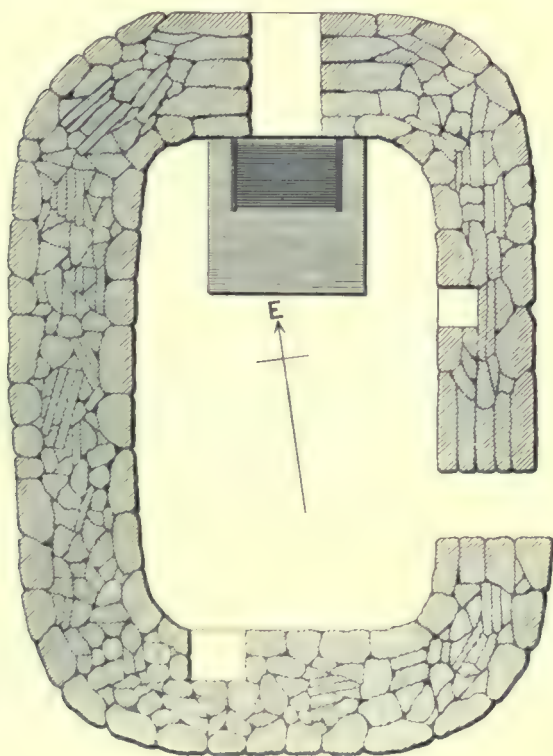
FIG. 39.—Teampull Sula Sgeir.

"In a comparatively level spot, closely surrounded by rocks, there is a low, rough, oval-shaped chapel (Fig. 39), internally measuring no more than 14 feet in length [8 feet wide at the middle, and 6 feet 4 inches at the ends],\* the extreme antiquity of which there seems no reason to question. On the outside (Fig. 40) the roof of this primitive cell is of curved form, but inside the rude vaulting, which may be said to commence almost from the ground, finishes somewhat short of the summit in so many heavy slabs laid horizontally across. Externally the building is a little dilapidated at both ends, and so is the roof; but within it is quite perfect, and seemingly noways altered from its original state. Entrance to it is by a low and very narrow flat-topped doorway, with sloping jambs [3 feet 5 inches in

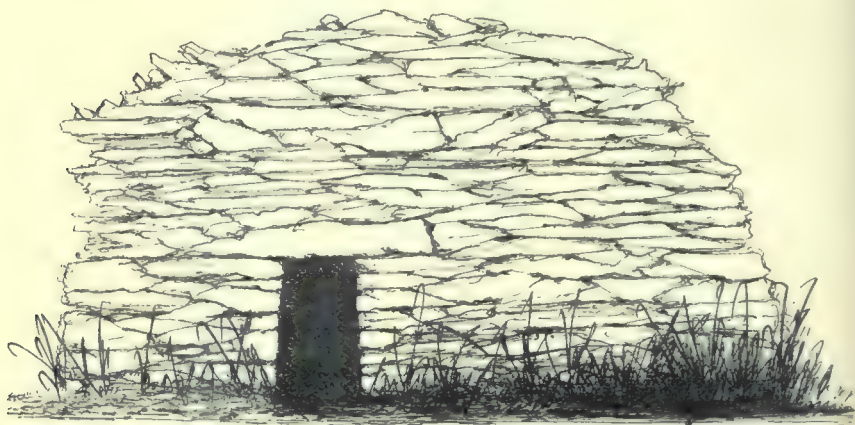
FIG. 40.—Teampull Sula Sgeir.

height, 16 inches wide at top and 22 inches at bottom]\* in the south wall. On its east is a small squared recess, and there is another recess of the same kind in the west wall. The only window is a small one, of squared form [2 feet 8 inches in length], in the east end, under which is an altar, flanked by slabs, set on edge, and raised on a slightly elevated dais, as is shown on the annexed plan."†

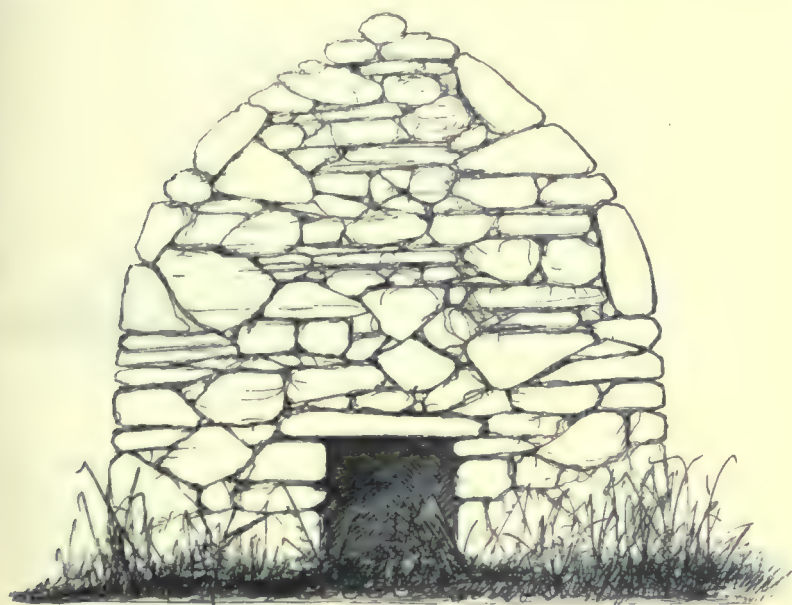
FIG. 41.—Teampull Beannachadh. West End

"The chapel of St. Flann, or Teampull Beannachadh (blessing) as it is commonly called . . . stands nakedly about the middle of the slope, unenclosed and with no indications of having ever been surrounded by a burial-ground. (Figs. 41, 42.) It is a very primitive looking thing, composed of rough stones joggled compactly together without lime. The form is a squared oblong, but not strictly regular, the external lengths of the north and south walls being respectively 11 feet 11 inches and 12 feet 2 inches, the east and west walls, 10 feet 3 inches and 9 feet 2 inches respectively ; [within the dimensions are—length 7 feet 3 inches ; width, 4 feet 5 inches.] \*

The walls vary in thickness from 2 feet 5 inches to 2 feet 11 inches, taper a little, and are covered with a stone roof internally flat, but following the obtusely pointed or cradle form of the gables on the outside. Exter-

nally, the total height of the cell is only 8 feet 6 inches; internally, 5 feet 9 inches. A narrow squared aperture, scarcely 3 feet in height [1 foot 10 inches in width],\* in the west end, is at once doorway and window, besides it there being no opening of any kind in the building.”†

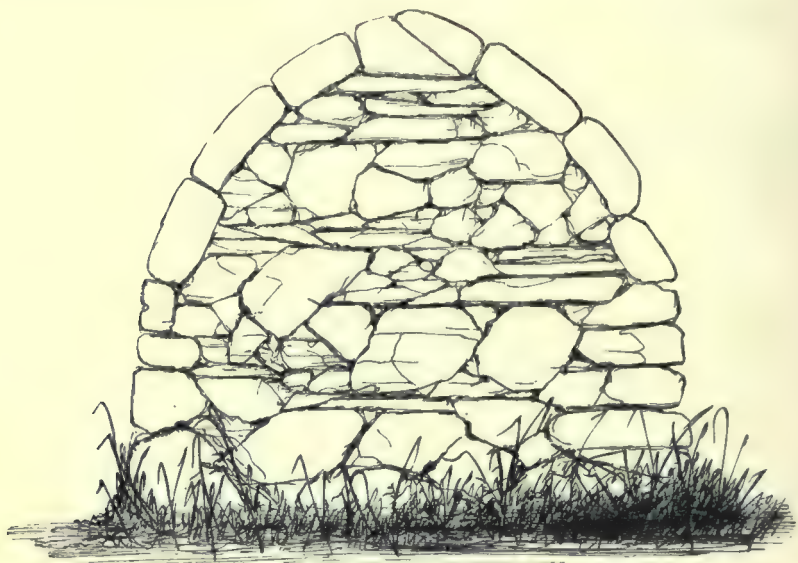
FIG. 42.—Teampull Beannachadh. East End.

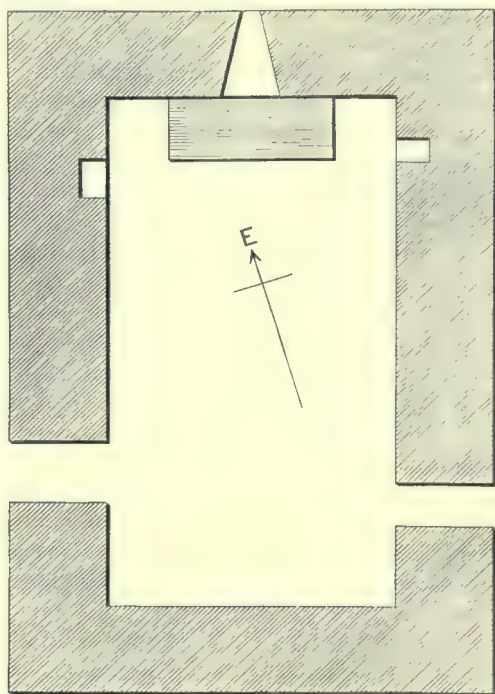
FIG. 43.—Tigh Beannachadh, Gallowhead.

greatly dilapidated chapel [a simple oblong], internally 18 feet 2 inches in length [by 10 feet 4 inches], with a broken east window, having an altar beside it and a doorway, and a niche in each of the side walls; the

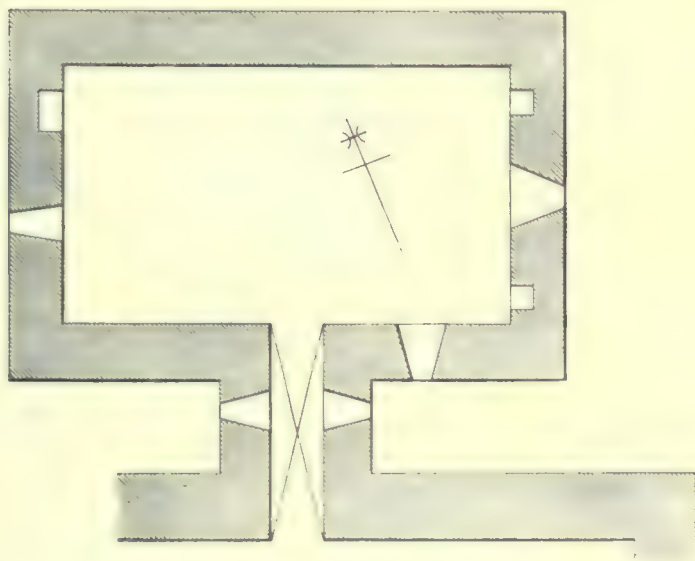
FIG. 44.

a broken round-headed doorway near west end of north wall. Connected with it on that side by a low semi-circular vaulted passage (Fig. 44), lighted by a small flat-headed window on each side, is the other chapel,

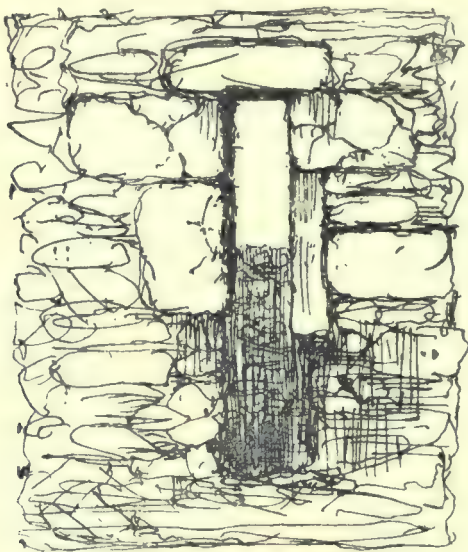
FIG. 45.

middle of north side. Window in north wall 3 feet 4 inches long and flat-headed. (Fig. 45.) No opening in east end.‡
